NAVAJO - BROWN VANDEVER URANIUM MINE

PRELIMINARY ASSESSMENT REFERENCES

PRELIMINARY ASSESSMENT FOR THE NAVAJO - BROWN VANDEVER URANIUM MINE

PATRICK MOLLOY  
HEALTH PHYSICIST, NAVAJO SUPERFUND OFFICE

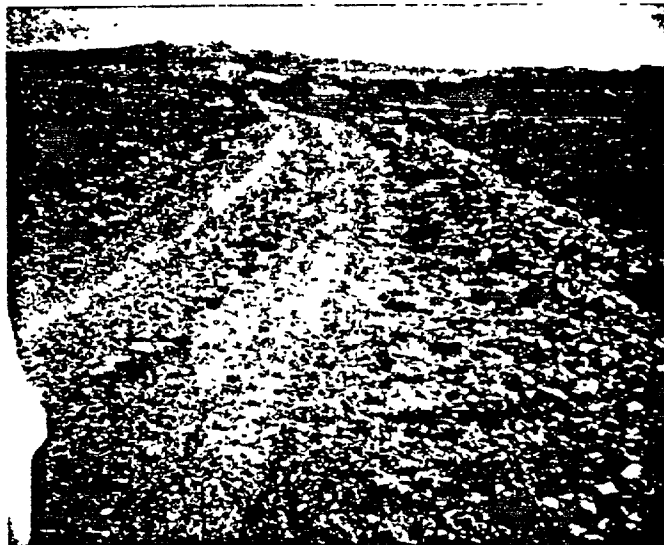
Reading: 105cpm (TSP-1) @ EDGE OF ROAD

7. DESCRIPTION "HOT ROAD" WEST OF B. V. RESIDENCES, SUR-  
FACE WORKS WASTE PILES @ RIGHT MIDDLEGROUND, MT. TAY-  
LOR @ UPPER LEFT BACKGROUND AS REFERENT

- \* The Navajo Superfund Office FIT digilert alerted (enabled) inside the vehicle being used for reconnaissance at one point along the "Hot Road" (3; Frame #22): enable/alert on the device is set at .098 mR.hr-1.

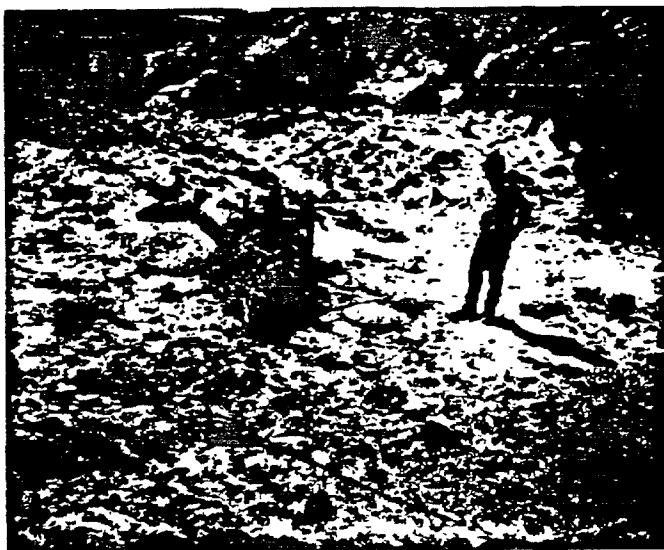
33<sup>rd</sup> FR.  
 (VENT. SH. VERTICAL!)

7. DESCRIPTION VERTICAL VENTILATION SHAFTS (2), HOSTEEN  
BROWN VANDEVER AT RIGHT MIDDLEGROUND, SHAFTS "300  
FT. DEEP" - B. V. TO P. MOLLOY, APRIL 11, 1990, LOOK-  
WNW

Two, two-foot diameter vertical shafts were excavated between the inclined adits and the timbered shaft in order to provide ventilation for the mining operation (3; frame #33); the ventilation shafts were reported to be approximately 300 ft. deep (Mr. Brown Vandever, personal communication, April 11, 1990).

- \* The vertical ventilation shafts are poorly capped and young children in the area could easily gain access to the excavations (3; Frame #33).
- \* One inclined adit is used for waste disposal (3; Frame #12).
